Customer Network Solutions

Correct installation of floodlights and connection boxes

22 April 2026

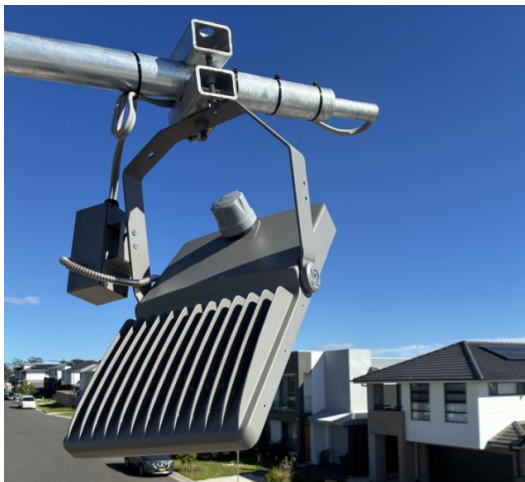
In addition, the connection box must be orientated correctly to prevent water ingress. While the floodlight angle is identified on the design, installers must also ensure the connection box is turned so it is positioned in a way that does not allow water to enter.

This image shows the floodlight and connection box mounted incorrectly

Please ensure floodlights are installed in accordance with the approved design, including the specified upcast angle of the light. The required angle is shown on the design and must be followed at installation.

- the floodlight upcast angle must be installed exactly as shown on the design
- the connection box must be turned to the correct orientation to prevent water ingress
- both requirements must be checked at the time of installation

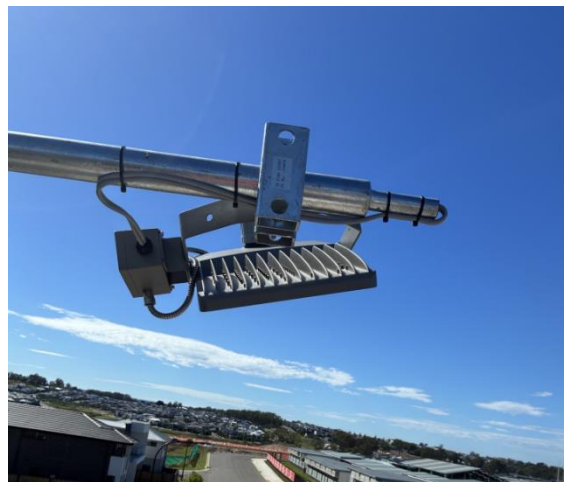
This image shows the correct mounting arrangement
